## Property Completion Agreement

Property ID:	4041
Property Address:	3750 York
Owner:	Roger Rodine
Phone:	303-296-8408

## Restoration Agreement

SITE NAME: VASQUEZ BOULEVARD AND I-70

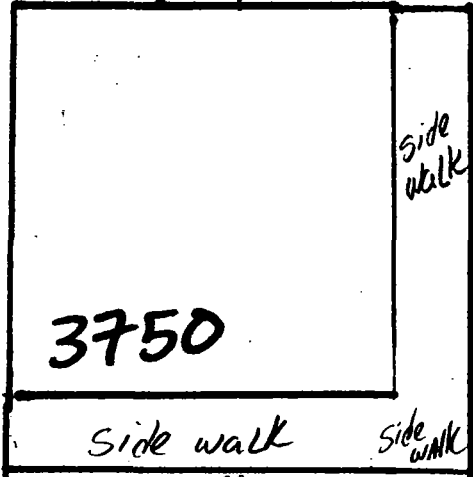
PIN  
4041

total 6437 sq ft drive way gravel

← REPLACE WITH  
DRIVE WAY GRAVEL
